Re: February 2013 Monthly Progress Report
Administrative Settlement Agreement and Order on Consent for Removal Action
U.S. EPA Region 10 Docket No. CERCLA 10-2009-0255
Gasco Sediments Site within the Portland Harbor Superfund Site

Attachment A Monthly Visual Monitoring Report for Pilot Cap Vicinity

Visual Observations Log Form

Monitoring Period: Monthly (Year 7)—February 2013

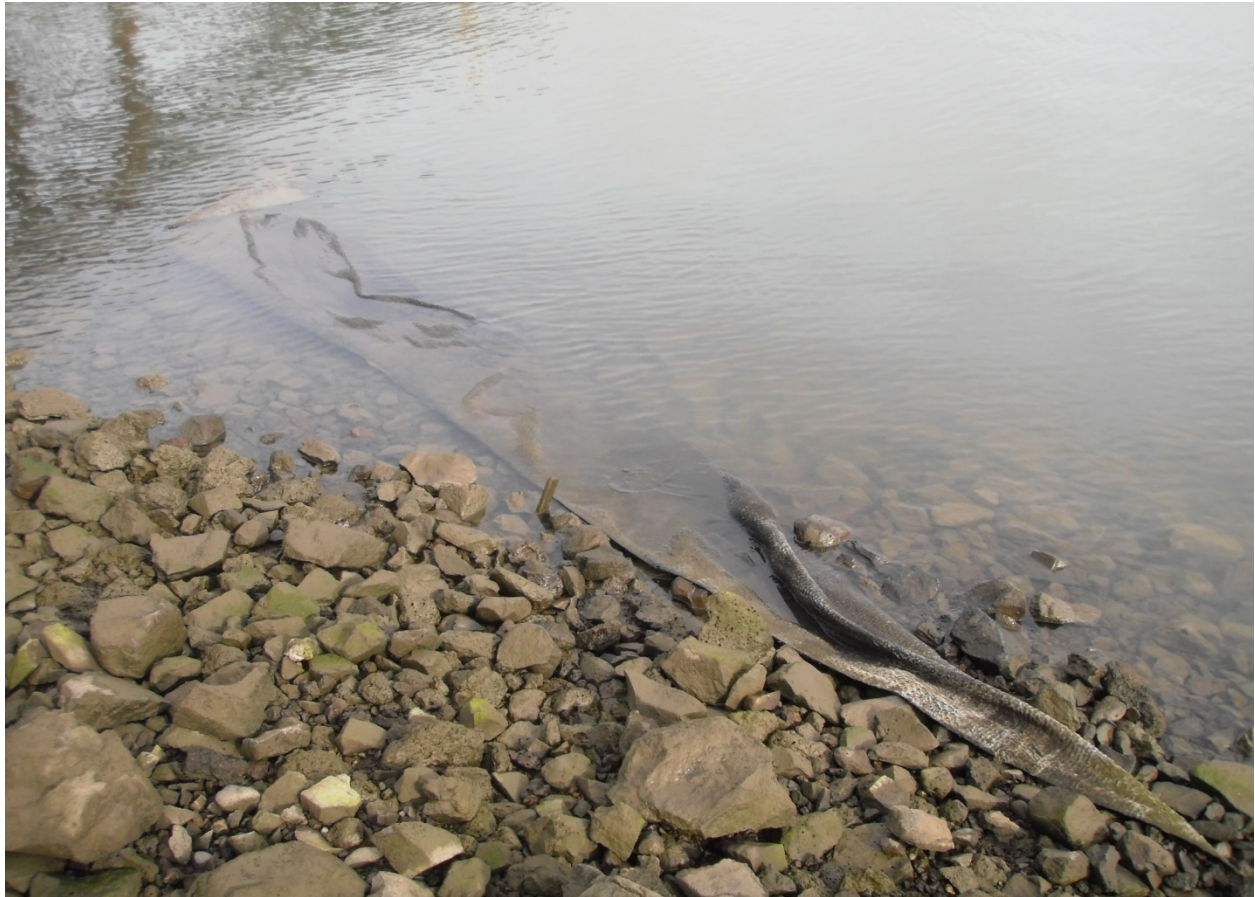
Photo 1 — *Visible section of organo-clay mat at downriver end of sediment cap (2/26/13):*

Observations of Erosion/Deposition: No erosion/deposition is evident along the shoreline. Four organoclay mat material segments are exposed and visible. One 20-foot section of organoclay mat is partly out of the water at the upriver extent of the cap area perpendicular to the shoreline. Two segments measuring 4-foot and 2-foot in length are exposed approximately 5 feet from the water's edge near the lateral mid-point of the cap area. One 40-foot section of organoclay mat material is exposed, 0-3 feet in the water, near the downriver extent of the cap area (see Photo 1).

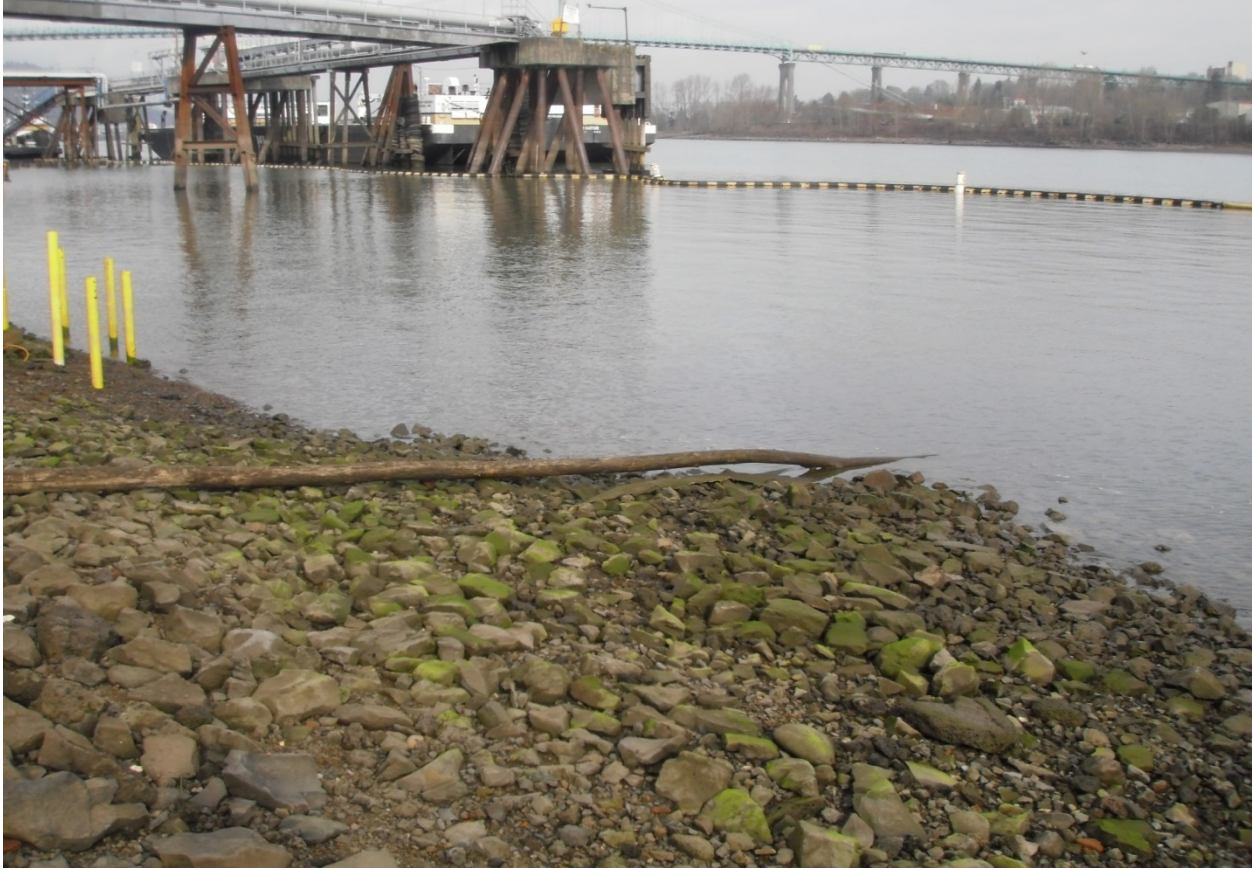
Photo 2 — *FAMM oil boom and mariner warning buoys in place across pilot cap area. 2/26/13):*

Observations of Long-term Controls (i.e., oil booms, organo-clay mat, etc.) During the observation, the Fuel and Marine Marketing (FAMM) containment boom was placed across the cap area, between the upriver corner of the ship dock and the wooden dolphin (near the upriver extent of the site and near the Siltronic Corporation outfall). Buoys that identify the cap area to mariners are in place as installed. The position of the FAMM oil boom, warning buoys, and a general overview of the site shoreline is shown in Photo 2.

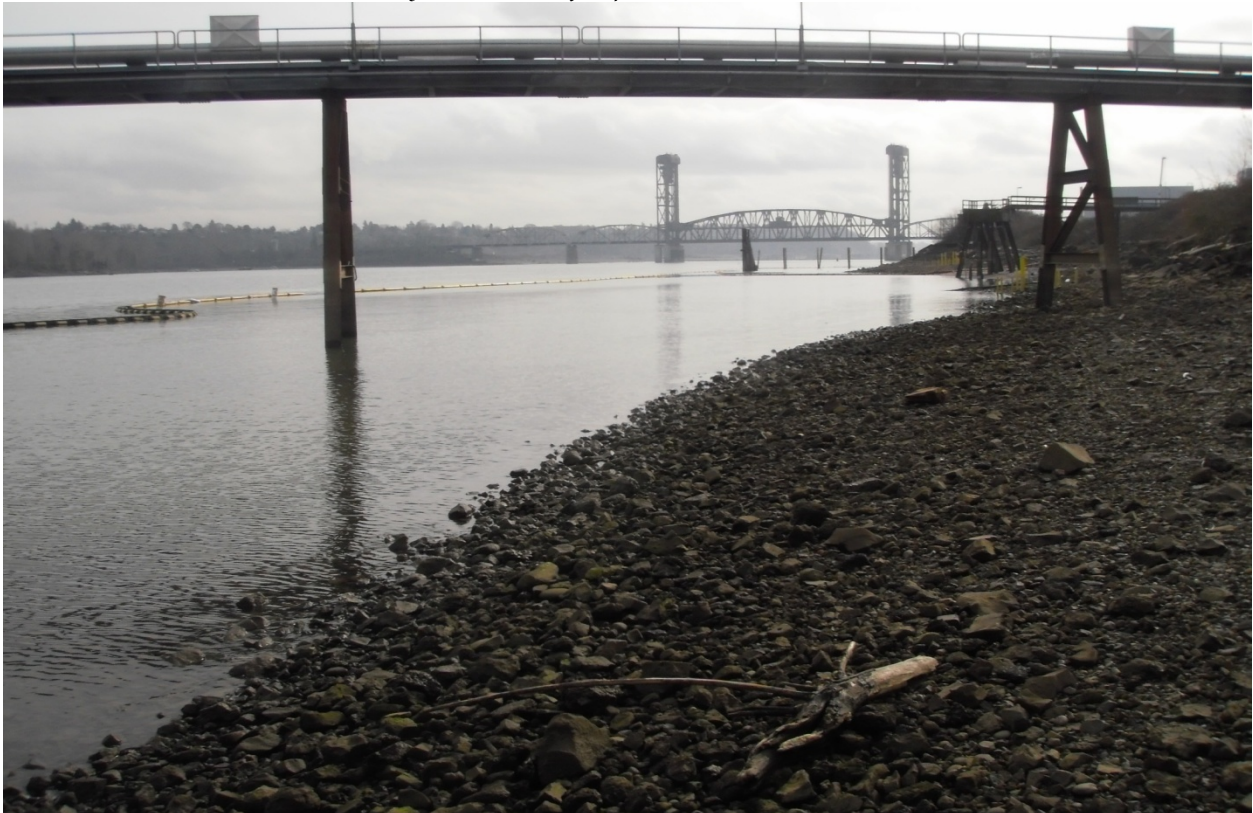
Photo 3 — *Conditions immediately downriver of cap area (2/26/13):*

No sheen is evident in or around the cap area. Photo 3 shows the water surface and shoreline immediately downriver of the sediment cap.
